Report on safety inspection cycle of outdoor storage tank facilities

By investigation committee

December, 2010

Ministry of Public Management, Home Affairs Posts and Telecommunications Fire and Disaster Management Agency Investigation committee for safety inspection cycle of outdoor storage tank facilities

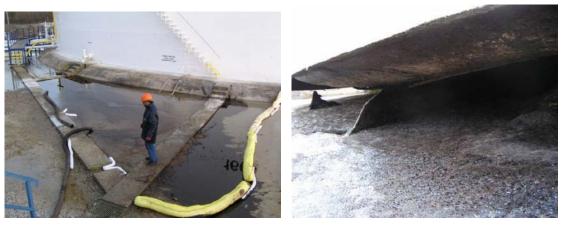
写真:当初の小流出状況

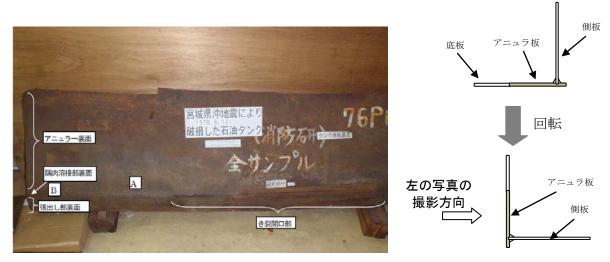
Figure 3.3.1 shows the photograph on the back side of annular plate of the tank (accident case with 2.6.1 d) broken by Miyagi-ken-oki Earthquake.

図 3.3.1 昭和 53 年宮城県沖地震で破断したタンクのアニュラ板裏面の腐食状況

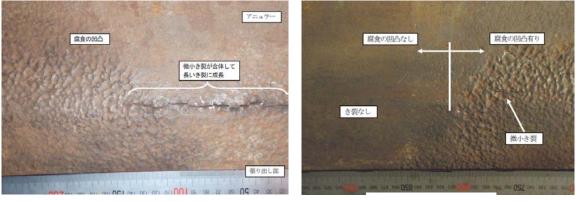
A部の拡大写真

Figure 3.3.2 shows the macro photography of the part A and B in above Fig. 3.3.1. In part A it can be confirmed for the micro-crack to connect and to grow up to a long crack. On the other hand, in part B the crack wasn't not found in the part without corrosion though there was a crack in the corroded part. So, it is thought that the local corrosion influences breaking the bottom plate from this.

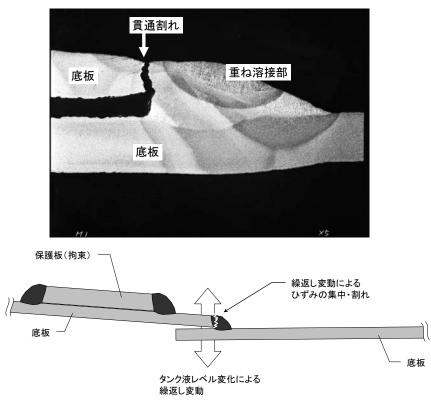
Weld breaking case in tank bottom generated in January, 2010. It presumes in the one and the office by the low cycle fatigue.
