Report on safety inspection cycle of outdoor storage tank facilities

By investigation committee

December, 2010

Ministry of Public Management, Home Affairs Posts and Telecommunications Fire and Disaster Management Agency Investigation committee for safety inspection cycle of outdoor storage tank facilities

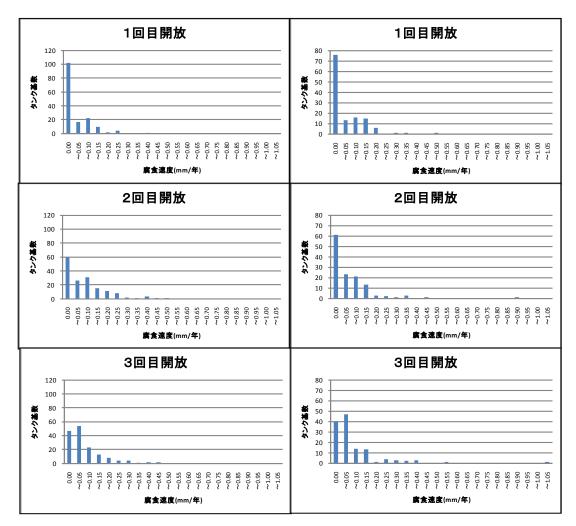
図 2.5.7 3回以上の開放実績があるタンクの各開放時の最大裏面腐食速度とタンク基数

表 2.5.2 3回以上の開放実績があるタンクの開放回数に対する 裏面腐食速度の平均値及び最大値並びに対象タンク基数

部位		第1回開放	第2回開放	第3回開放
	腐食速度の平均値 (mm/年)	0.031	0.073	0.066
アニュラ板	腐食速度の最大値 (mm/年)	0.39	0.48	0.45
	タンク基数	158基	158基	158基
	腐食速度の平均値 (mm/年)	0.044	0.056	0.071
底板	腐食速度の最大値 (mm/年)	0.48	0.9	1.14
	タンク基数	129基	129基	129基

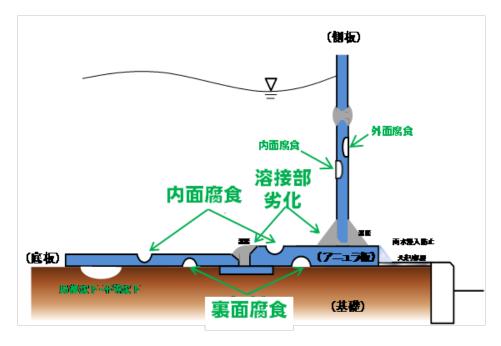
図 2.6.1 タンク底部に係る経年劣化要因

Figure 2.6.1 shows the schematic figure of the factor of aging deterioration of the tank. The following three factors are thought as the main causes of the spill accident from the bottom of the tank (the factor of aging deterioration).

•uneven settlement and local subsidence of base (preceding clause case (1) and (3))

- The followings are thought to influence the deterioration factor of the tank bottom.
- •contents, liquid temperature, properties of sludge, and deterioration in inside coating, etc.
- •entering of water into the back side of bottom plate and material of base, groundwater levels, and distance from rivers etc.
- $\cdot$  hydraulic pressure and its change and incipient defect in weld etc.

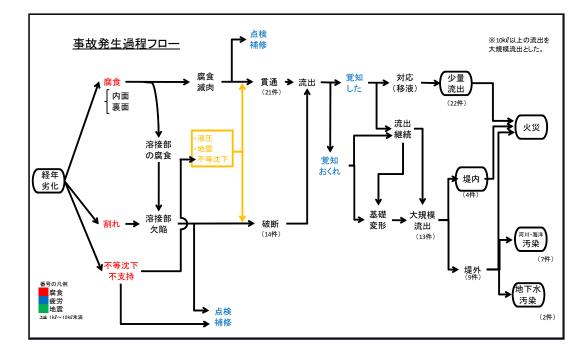
図 2.6.2 底部流出事故の事故発生フロー

The process from the aged deterioration of the bottom of the tank to the spill accident was summarized in Figure 2.6.2. The number of cases in parentheses in the figure was a number of accidents extracted from Table 2.3.1 and Table 2.3.2 of Chapter 2 that related to 1,000 kl or more in tank capacity and corresponded to each item. The deterioration part where strength decreased with the passing age due to corrosion or a weld defect (or these combined) occurred in the tank. The tank returns to the healthy condition again if the deterioration part in prior is found by the major inspection and is repaired. But when further deterioration was progressing ahead from the major inspection or the deterioration part was overlooked by the major inspection, the deterioration part arrives at the spill accident by such cause as a hydraulic pressure (change), an uneven settlement, a local subsidence, and the earthquake. 34 spill accidents from such a bottom have occurred about the one of 1,000 kiloliters or more in capacity since 1974. The one that was broken by the combined factor with thinning by the corrosion and defect in the weld was included in that, though all causes of breaking of the weld was classified here as fatigue. In this figure, there were 13 accidents in which the spill of 10 kl or more that corresponded to 50 drum and assumed to be a large-scale spill. There is the one that seems to report on the amount of oil that was able to be collected as an amount of spill according to the office, and is the one that it is not possible to confirm it about the accuracy of the amount of spill.

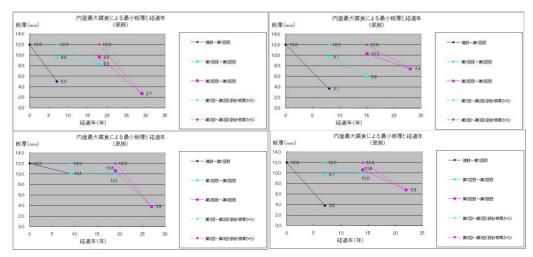
図 3.1.3 収集し分析に用いたデータ中で内面腐食速度の大きな事例

(7) The corrosion rate differs at the time of each opening, and the fluctuation band of the corrosion rate has to be considered when penetration is forecast. The ratio of the maximum value to the minimum value (bottom plate 1.4 and annular plate 1.7) of the one that the maximum corrosion rate of each tank obtained at the time of each opening was averaged to the number of tanks (Table 2.4.2) are assumed as the width. In civil standard EEMUA of Europe, the value of 2.0 (reciprocal of "Reliability coefficient 0.5") is indicated as a fluctuation band to the corrosion rate (2.7.2 references). Because this penetration forecast is virtually examined, the above-mentioned assumption thought to be almost real was used. Therefore, it is necessary to note that it is not the one of showing the fluctuation band that should be considered in practical system. Even if the highest corrosion rate (1.5-2.6mm/year: Figure 2.4.1) of the case where inside corrosion progressed rapidly and that arrived at spill accident.

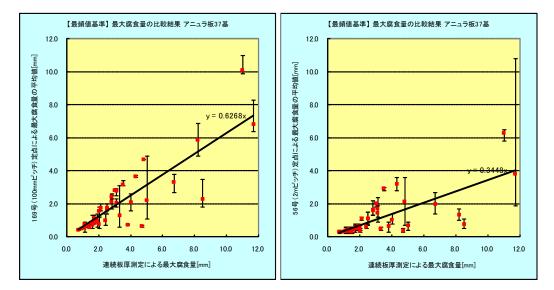
図 3.2.3 アニュラ板の定点測定結果と連続板厚測定結果の相関分析結果(5通りの抽出箇 所設定方法による平均を■で、結果の幅を垂直の線分で示す。)

(2) Regression analysis result of the back side corrosion depth detected by fixed point metrology and the back side corrosion depth by continuous plate thickness metrology The result of the analysis is shown in Figure 3.2.3 and Figure 3.2.4 ( $\Box$  is a mean value of the result by fixed point measurement method in which five kinds of points of a tank are set, and a vertical segment shows the scattering by the method of setting the fixed point, in the figures). In both figures, the left one simulates the 169th notification, the right is a result for simulating the 56th notification. The relation between the back side corrosion depth detected by fixed point metrology using the mean value and the one by continuous plate thickness metrology was expressed regression line, from which inclination the ratio how many times the real maximum corrosion depth of the one by fixed point metrology using the tank parameter etc. of the plate thickness data used for this analysis is shown in references-4.

It is thought that the real maximum back side corrosion depth of the tank bottom is multiplication of the coefficient (reciprocal of the inclination of the regression line) in Table 3.2.1 by the maximum back side corrosion depth obtained by the fixed point metrology on the average.

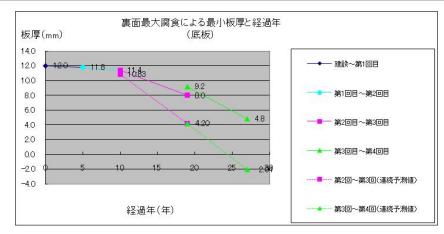
図 3.2.5 タンクの開放ごとの裏面腐食の履歴の例

(8)The one with a short years of each approximation process is made the penetration year due to the back corrosion of the bottom board of a tank concerned (Refer to Figure 3.2.6 for the procedure of the examination).

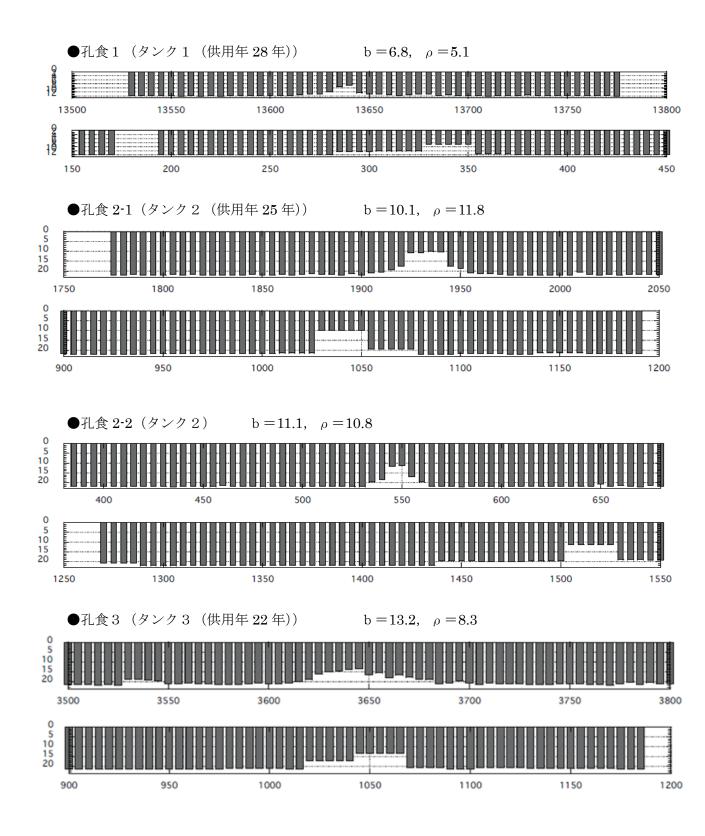
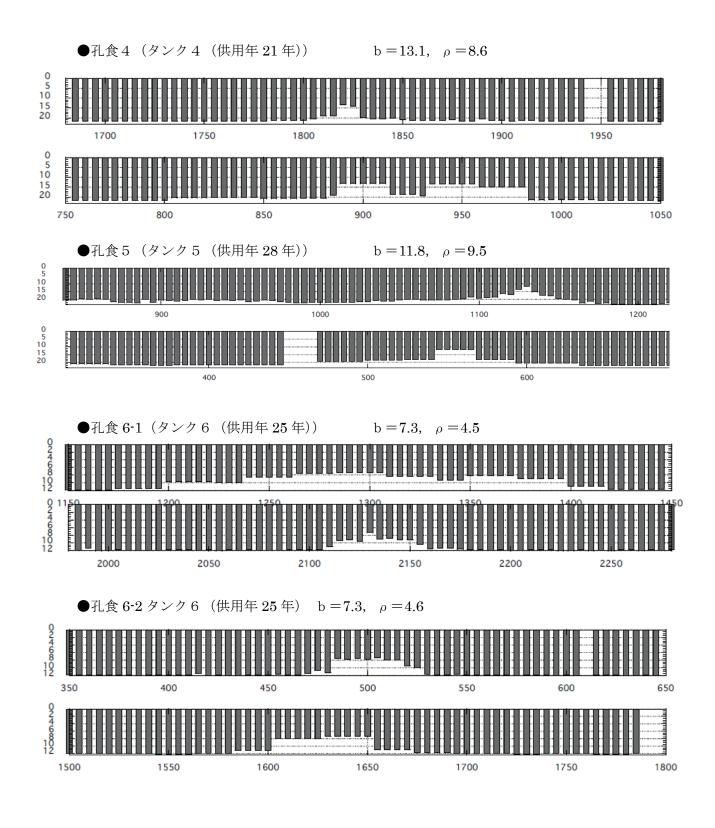
図 3.3.5 表 3.3.1 で耐震性を試算した裏面腐食形状

As for the possibility of cycle fatigue fracture, it is ..low.. reference against the back corrosion of the example of the shape of cross section of deep corrosion with the continuous board thickness measurement result. It calculated it provisionally concerning safety by the showed in five method. The result is as shown in Table 3.3.1. Figure 3.3.5 shows the calculated corrosion shape.

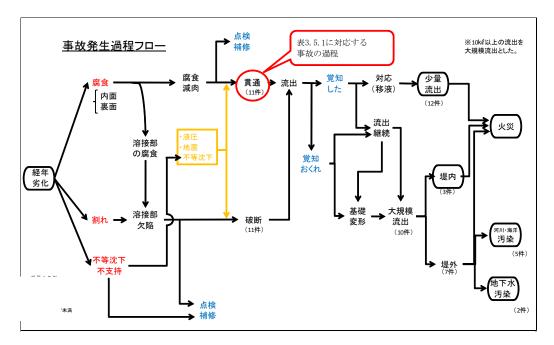
図 3.5.1 底部流出事故の事故発生フロー(図 2.6.2 に表 3.5.1 の結果に対応する過程を 記入。図中の数値は容量1万キロリットル以上の屋外貯蔵タンクの過去の事故件数。)

The above-mentioned presumption result is based on the assumption etc. shown in the above-mentioned note though an accurate comparison with the tank accident of the reality is difficult, Especiallydo fundamental period do accident frequency table object tankcardinal number installation passage yr radical age divide new law tank number putcalculation to the extent that increase recently capacity tank bottom outflow accident frequency above-mentioned presumption frequency increase accident frequency.

It is what based on constant assumption, and it is actually thought to grow more than this from the inclusion also of assumption that lengthens the presumption year (Danger is evaluated small) in that though these evaluations are the one that only "Penetration hole formation due to corrosion" that presumption is possible was assumed. In addition, it is expected that the influence on safety when the cycle is extended grows more than this , considering "Occurrence of the accident because of a weld breaking" that the evaluation is difficult and "Generation of the tank where earthquake resistance cannot be confirmed" (The generation number of accidents grows). The one that corrosion progressed like the half ditch of initial board thickness at a present cycle was presumed though the influence on earthquake resistance was not able to be evaluated quantitatively though it was a reference trial calculation value that the one for which attention was necessary came out.

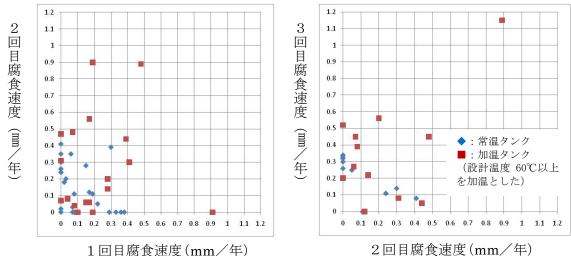
図 4.3.1 1回目開放時の裏面腐食速度と2回目開放時の裏面腐食速度(左)及び2 回目開放時の裏面腐食速度と3回目開放時の裏面腐食速度(右)

As for the one large the back corrosion depth having been reported, Figure 4.3.1 is seeing of the back corrosion speed (one by the fixed point metrology) at the time of each opening of an individual tank (Figure 2.5.4 and Figure 2.5.5 re-[\*\*]) among the new law tanks. It is difficult to understand the corrosion rating of each times of open has changed from this figure, and to obtain the upper bound of the change ratio objectively. The change, the base of deterioration in the back anti-corrosion measures, deterioration in the rain water going into it preventive measure, and the storing temperature, and changes in the contact situation with the bottom board, etc. are actually thought as a factor that the back corrosion speed changes.

On the other hand, the back corrosion speed requested from this figure by the fixed point metrology in the normal temperature tank has been installed within the range of 0.4mm or less/year. It is assumed that it is 0.4mm or less/year even if the back corrosion speed changes when the object tank of the extension of the inspection cycle examined this time is made a normal temperature tank whose upper bound value at the back corrosion speed measured by the continuous board thickness metrology is 0.2mm/year. Even if the situation with low possibility that the back corrosion of 0.4mm/year continues for 15 years that are the upper bounds for the extension period is developed, the back corrosion depth of 15 years is 6mm. Even if the situation with lower possibility that such a situation occurs in the minimum board thickness part in the tank where there is board thickness near the minimum value 9mm of the management by objectives board thickness in the bottom plate and the back corrosion speed till then is low is assumed, the remaining board thickness of 3mm or more can be secured. The situation is assumed according to the trial calculation ..low.. result of the probabilistic assessment of cycle fatigue fracture of the local corrosion part (Table 3.4.1) very the possibility low to begin with though safety in this board thickness when progressing corrosion is to ditch it cannot be confirmed. And, you may think that it can secure safety within the reasonable range because it remarkably assumes the tough going, that the large-scale earthquake occurs in the end at the cycle of open.

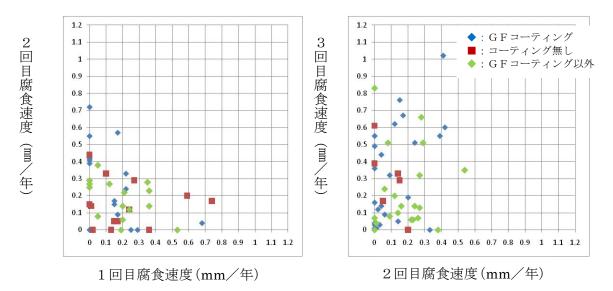
図 4.3.2 1回目開放時の内面腐食速度と2回目開放時の内面腐食速度(左)及び2 回目開放時の内面腐食速度と3回目開放時の内面腐食速度(右)

It is clarified that the coating constructed by the coating indicator doesn't flake off easily though big inside corrosion of the corrosion rating might be caused in the tank where the coating was constructed when the coating flakes off. [A]. It is suitable to drink and to confirm the coating is maintained excellently when it is assumed that it was constructed by the coating indicator, and the performance more than the equal to it is possessed, and opens the tank. [I]. Assuming that it is a tank without the coating, and the inside corrosion speed will be 0.1mm or less in 2 in Kon opening or more/year soon drinking is suitable.

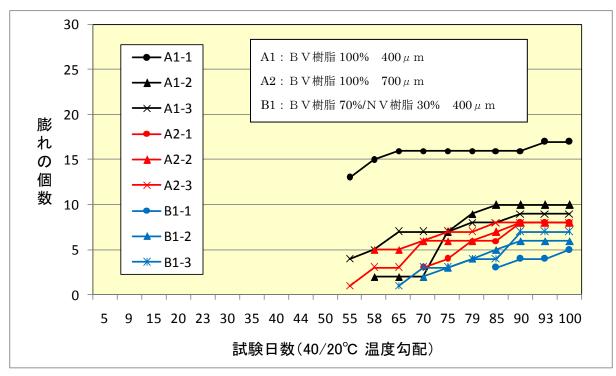
図 5.2.2 各試験片の膨れ発生個数と浸漬日数

?The number of swelling generation of the 100th days was A1:9?17 piece and A2:8 (12 on the average)(8 on the average) piece and B1:5?7 (6 on the average) pieces, and there were a lot of A1, and A2 and B1 showed few tendencies. Refer to Figure 5.2.2 for the relations between the swelling generation number and the number of maceration Japan of each test piece.

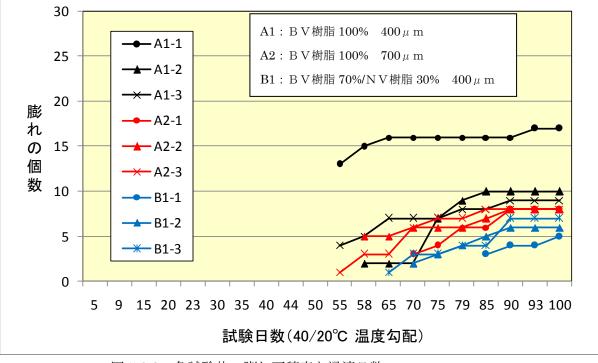
図 5.2.3 各試験片の膨れ面積率と浸漬日数

?The relations between the swelling area and the number of maceration Japan of each test piece were summarized in Figure 5.2.3. A1-1 is in three test pieces of A1(400 $\mu$ m) and it is in the swelling situation of the occurrence as for paints and the film thickness as which the swelling generation number and the area are a lot, and are the most same a plain difference. There is B1(400 $\mu$ m) by B1-1 in three test pieces, and the swelling generation is most and it is late in the swelling situation of the occurrence is hardly admitted by three pieces in A2(700 $\mu$ m).

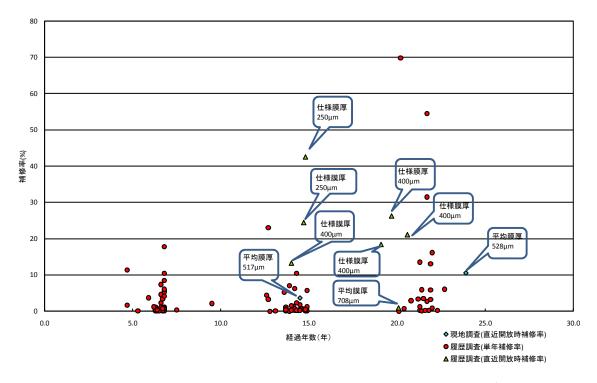
図 5.3.2 タンクの経過年数と開放時の BV 樹脂 GF コーティングの補修割合

The tank cardinal number where the repair ratios at the time of each opening were able to be collected was 39. Moreover, the one that the repair ratio when Kon would open it soon was able to be understood was seven. The relation to the repair ratio of the coating when the number of years elapsed for the coating and opening it is shown and the one that Figure 5.3.2 and the repair ratio of the coating at the time of each opening accumulated is shown in Figure 5.3.3.

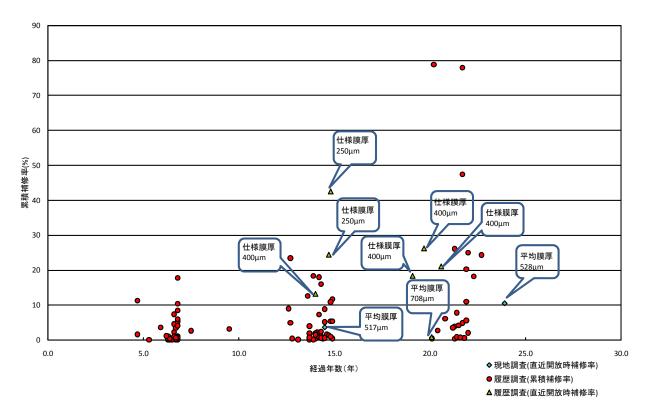
図 5.3.3 タンクの経過年数と開放時のBV樹脂GFコーティングの累積補修割合

A lot of things with a high repair rate come to be shown in Figure 5.3.2 when 20 years are exceeded though a red plot of Figure 5.3.2 and Figure 5.3.3 is BV resin GF coatings (Actual film thickness data is uncertain) constructed by the specification of minimum film thickness 250µm, and conditions of performance are also uncertain.

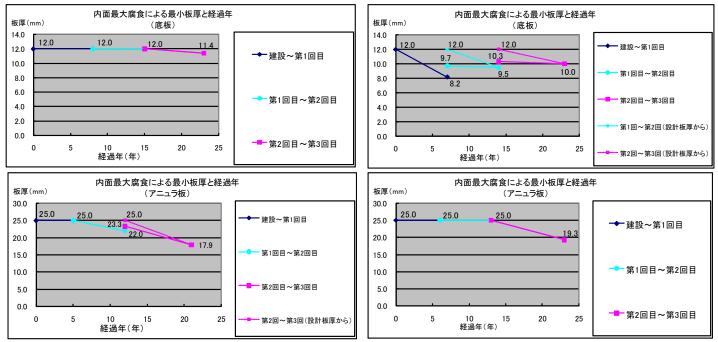
図 5.5.1 GFコーティングが施工されているタンクの内面腐食履歴の例

It is understood to provide a big as follows difference as an inside corrosion prevention function of the tank where the GF coating is constructed from Figure 5.5.1.

·Inside corrosion hardly progresses to the third times in the tank on the left.

•Inside corrosion progressed to the tank under the left since it opened the second though the inside corrosion prevention function was provided until the first opening it.

•An upper right tank constructs the GF coating when the first opening it, and inside corrosion doesn't progress after that.

•Inside corrosion progressed to a lower right tank since it opened the third though the inside corrosion prevention function was provided until the second opening it.

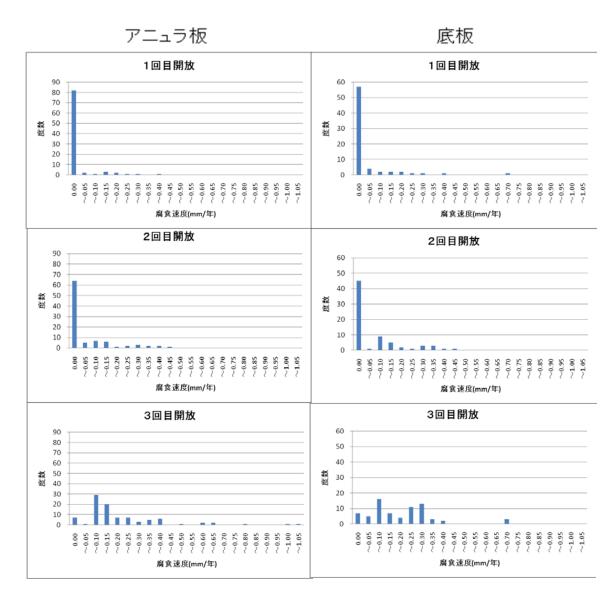
図 5.5.2 建設当初からGFコーティングが施工されているタンクの 開放ごとの内面腐食速度の推定下限値

The analysis of the inside corrosion prevention function due to the aged deterioration of the coating was executed from past inside corrosion history data. Figure 5.5.2(The presumption lower bound value at the inside corrosion speed; Figure 2.4.6 re-[\*\*]) and Figure 5.5.3(The presumption upper bound value at the inside corrosion speed; Figure 2.4.7 re-[\*\*]) are showing of the frequency distribution at the maximum, inside corrosion speed of each tank requested when the tank where the GF coating is constructed is opened each. A mean value and the maximum value were brought together in Table 5.5.1 and Table 5.5.2(Table 2.4.5 and Table 2.4.6 re-[\*\*])).

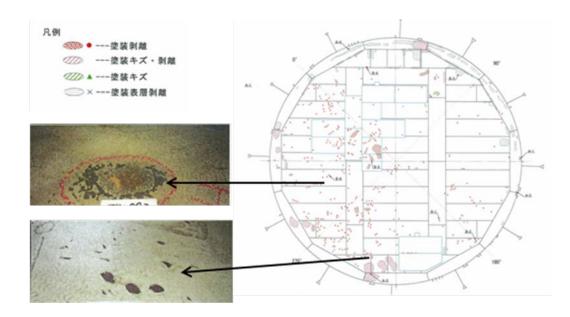
図 5.5.4 コーティング目視検査記録

•When opening it in 2010, flaking off and inside corrosion of the coating were found. A lot of flaking off parts of the coating exist though Figure 5.5.4 is a coating visual inspection record when the tank is opened. The photograph is showing of the flaking off situation. •Figure 5.5.5 is an inside corrosion check of bottom board record. It occurs on the [anyura] board and inside corrosion of 6.9mm or less occurs in 3.5mm and the bottom plates. When opening it in 2001, inside corrosion of 1.8mm or more is repaired. •The meat vigor repair is executed at the time of each opening, and this tank is thought that the corrosion prevention function of the coating was low. •Paints with low heat resistance performance were used. •The erosive environment is severe because of the influence of contents (high aroma and temperature).

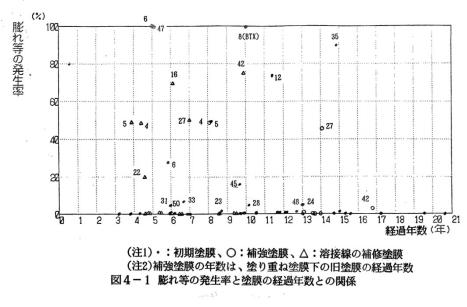
図 5.5.9 民間タンクのタンク経過年とコーティングの膨れ発生率

generated. As for the GF coating that follows the coating indicator from the above-mentioned, it is understood that the inside corrosion prevention function is high. (reference)Figure 5.5.9 is 6 that is the result that a similar investigation was done in 1996. )There is the one that the swelling has been hardly generated, too and it is understood that the difference is large in an old coating at the construction age the anticorrosive effect of the paint film though there are a lot of one that the swelling was generated. A private object tank is the main, and paints are contained excluding the GF coating.

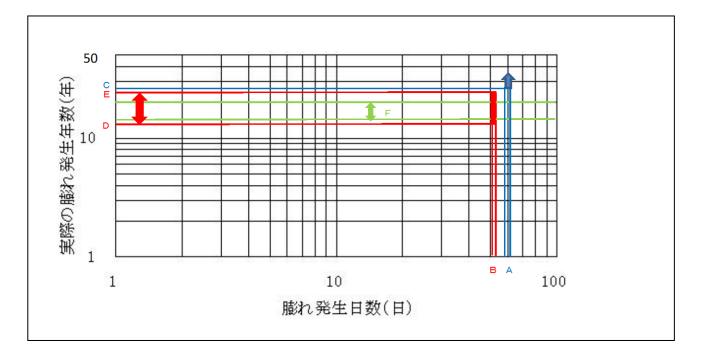
The swelling occurrence time from the temperature inclination soaking examination result of 700µm when you adopt the mean value of three examinations (58?61) in 2010 fiscal year

B:The swelling occurrence time from the temperature inclination soaking examination result of 400 $\mu$ m when you adopt the mean value of three examinations (52?56) in 2010 fiscal yearC:The GF coating of about 700 $\mu$ m considers the swelling of three local investigation results of 700 $\mu$ m (852  $\mu$ m in the average film thickness of average 485 $\mu$ m of the lowest film thickness and the bottom plate, 912  $\mu$ m in the average of the [anyura] board film thickness, and the specification film thickness: lowest and 430 $\mu$ m and average 650 $\mu$ m) to be a swelling due to the defect of happening by accident in 2009 fiscal year, and : when thinking that the life is expected for 26 years or more.

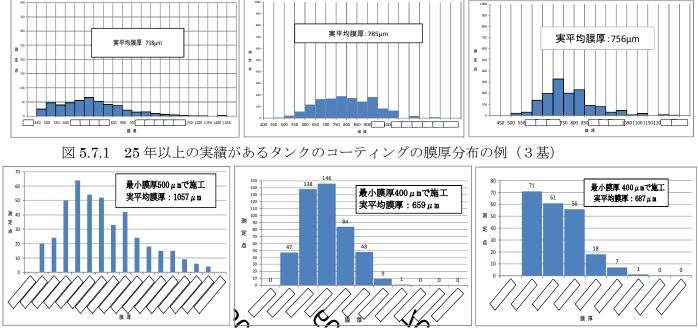
図 5.7.2 最低膜厚が 400 µ m以上となるよう施工されたタンクのコーティングの 膜厚分布の例(3基)

If it was a paint film of average film thickness 700µm level, it was clarified that there was life for about 26 years from the examination to the foregoing paragraph. It was thought that the life of the paint film was influenced from a comprehensive viewpoint by the average film thickness if no homogeneity of the environment in tanks of the distribution of the sludge and moisture and the temperatures, etc. was considered, and was clarified also of receiving of the deterioration situation the influence of the film thickness from the result of the survey of the tank where durability had been exceeded. It is necessary to take account to the distribution of the film thickness to provide for the life long-term that exceeds 20 years from this. Figure 5.7.1 shows the example of the thickness distribution of the paint film with the life for about 26 years. These are the one constructed by the specification "Minimum film thickness 430µm or more and average film thickness 650µm or more". On the other hand, the average film thickness is not provided for, and the example of the film thickness of the paint film with the life so the paint film constructed by the specification "Minimum film thickness of the paint film constructed by the specification "Minimum film thickness of the paint film constructed by the specification "Minimum film thickness of the paint film constructed by the specification "Minimum film thickness of the paint film constructed by the specification "Minimum film thickness of the paint film constructed by the specification "Minimum film thickness of the paint film constructed by the specification "Minimum film thickness of the paint film constructed by the specification "Minimum film thickness of the paint film constructed by the specification "Minimum film thickness of the paint film constructed by the specification "Minimum film thickness 400µm or more" is shown in Figure 5.7.2.

It is possible that the life of the paint film is influenced by a big film thickness (That is, it is thinner than the average more partial) to be distributed with the film thickness biased like the example in the right of Figure 5.7.2. Figure 5.7.3 shows the image of the distribution of the film thickness. The paint film (Figure 5.7.1) that was able to confirm the life for about 26 years has the thickness distribution like the left side of figure, and there is the one with the biased distribution from the consideration only of minimum film thickness shown as a specification in the tank in Figure 5.7.2 construction, too. Even if an extreme case is assumed and the average film thickness is the same as a left one of figure for the thickness distribution like the right side of Figure 5.7.3, the life must be different from the paint film with a left thickness distribution because a lot of parts where the film thickness is thin exist.

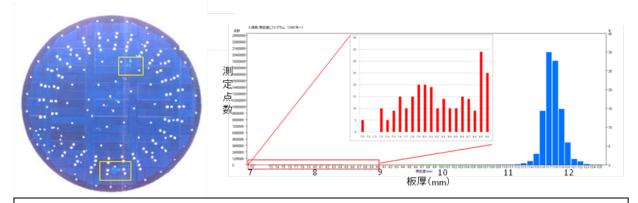
$\cdot$ A left the above chart is showing of the board thickness of the tank bottom. A blue part is a part where corrosion doesn't progress, and a yellow part in a yellow frame is a part where the board has thinned due to the back corrosion.

$\cdot$ A right the above picture is showing of the result of a measurement of the thickness of the bottom plate in a left tank (The measurement point is almost proportional to the area) by the measurement point of each board thickness. The majority of board thickness are in the range from 11.3 to 12.3 millimeters, and the part that has decreased within the range from 7.0 to 9.0 millimeters in board thickness exists, too.
